HAZARDOUS MATERIALS EVALUATION REPORT

BOW TO CONCORD I-93 IMPROVEMENTS BOW / CONCORD, NEW HAMPSHIRE

NH State Project No. 13742

**Nobis Project No. 87810.00
AUGUST 8, 2018**

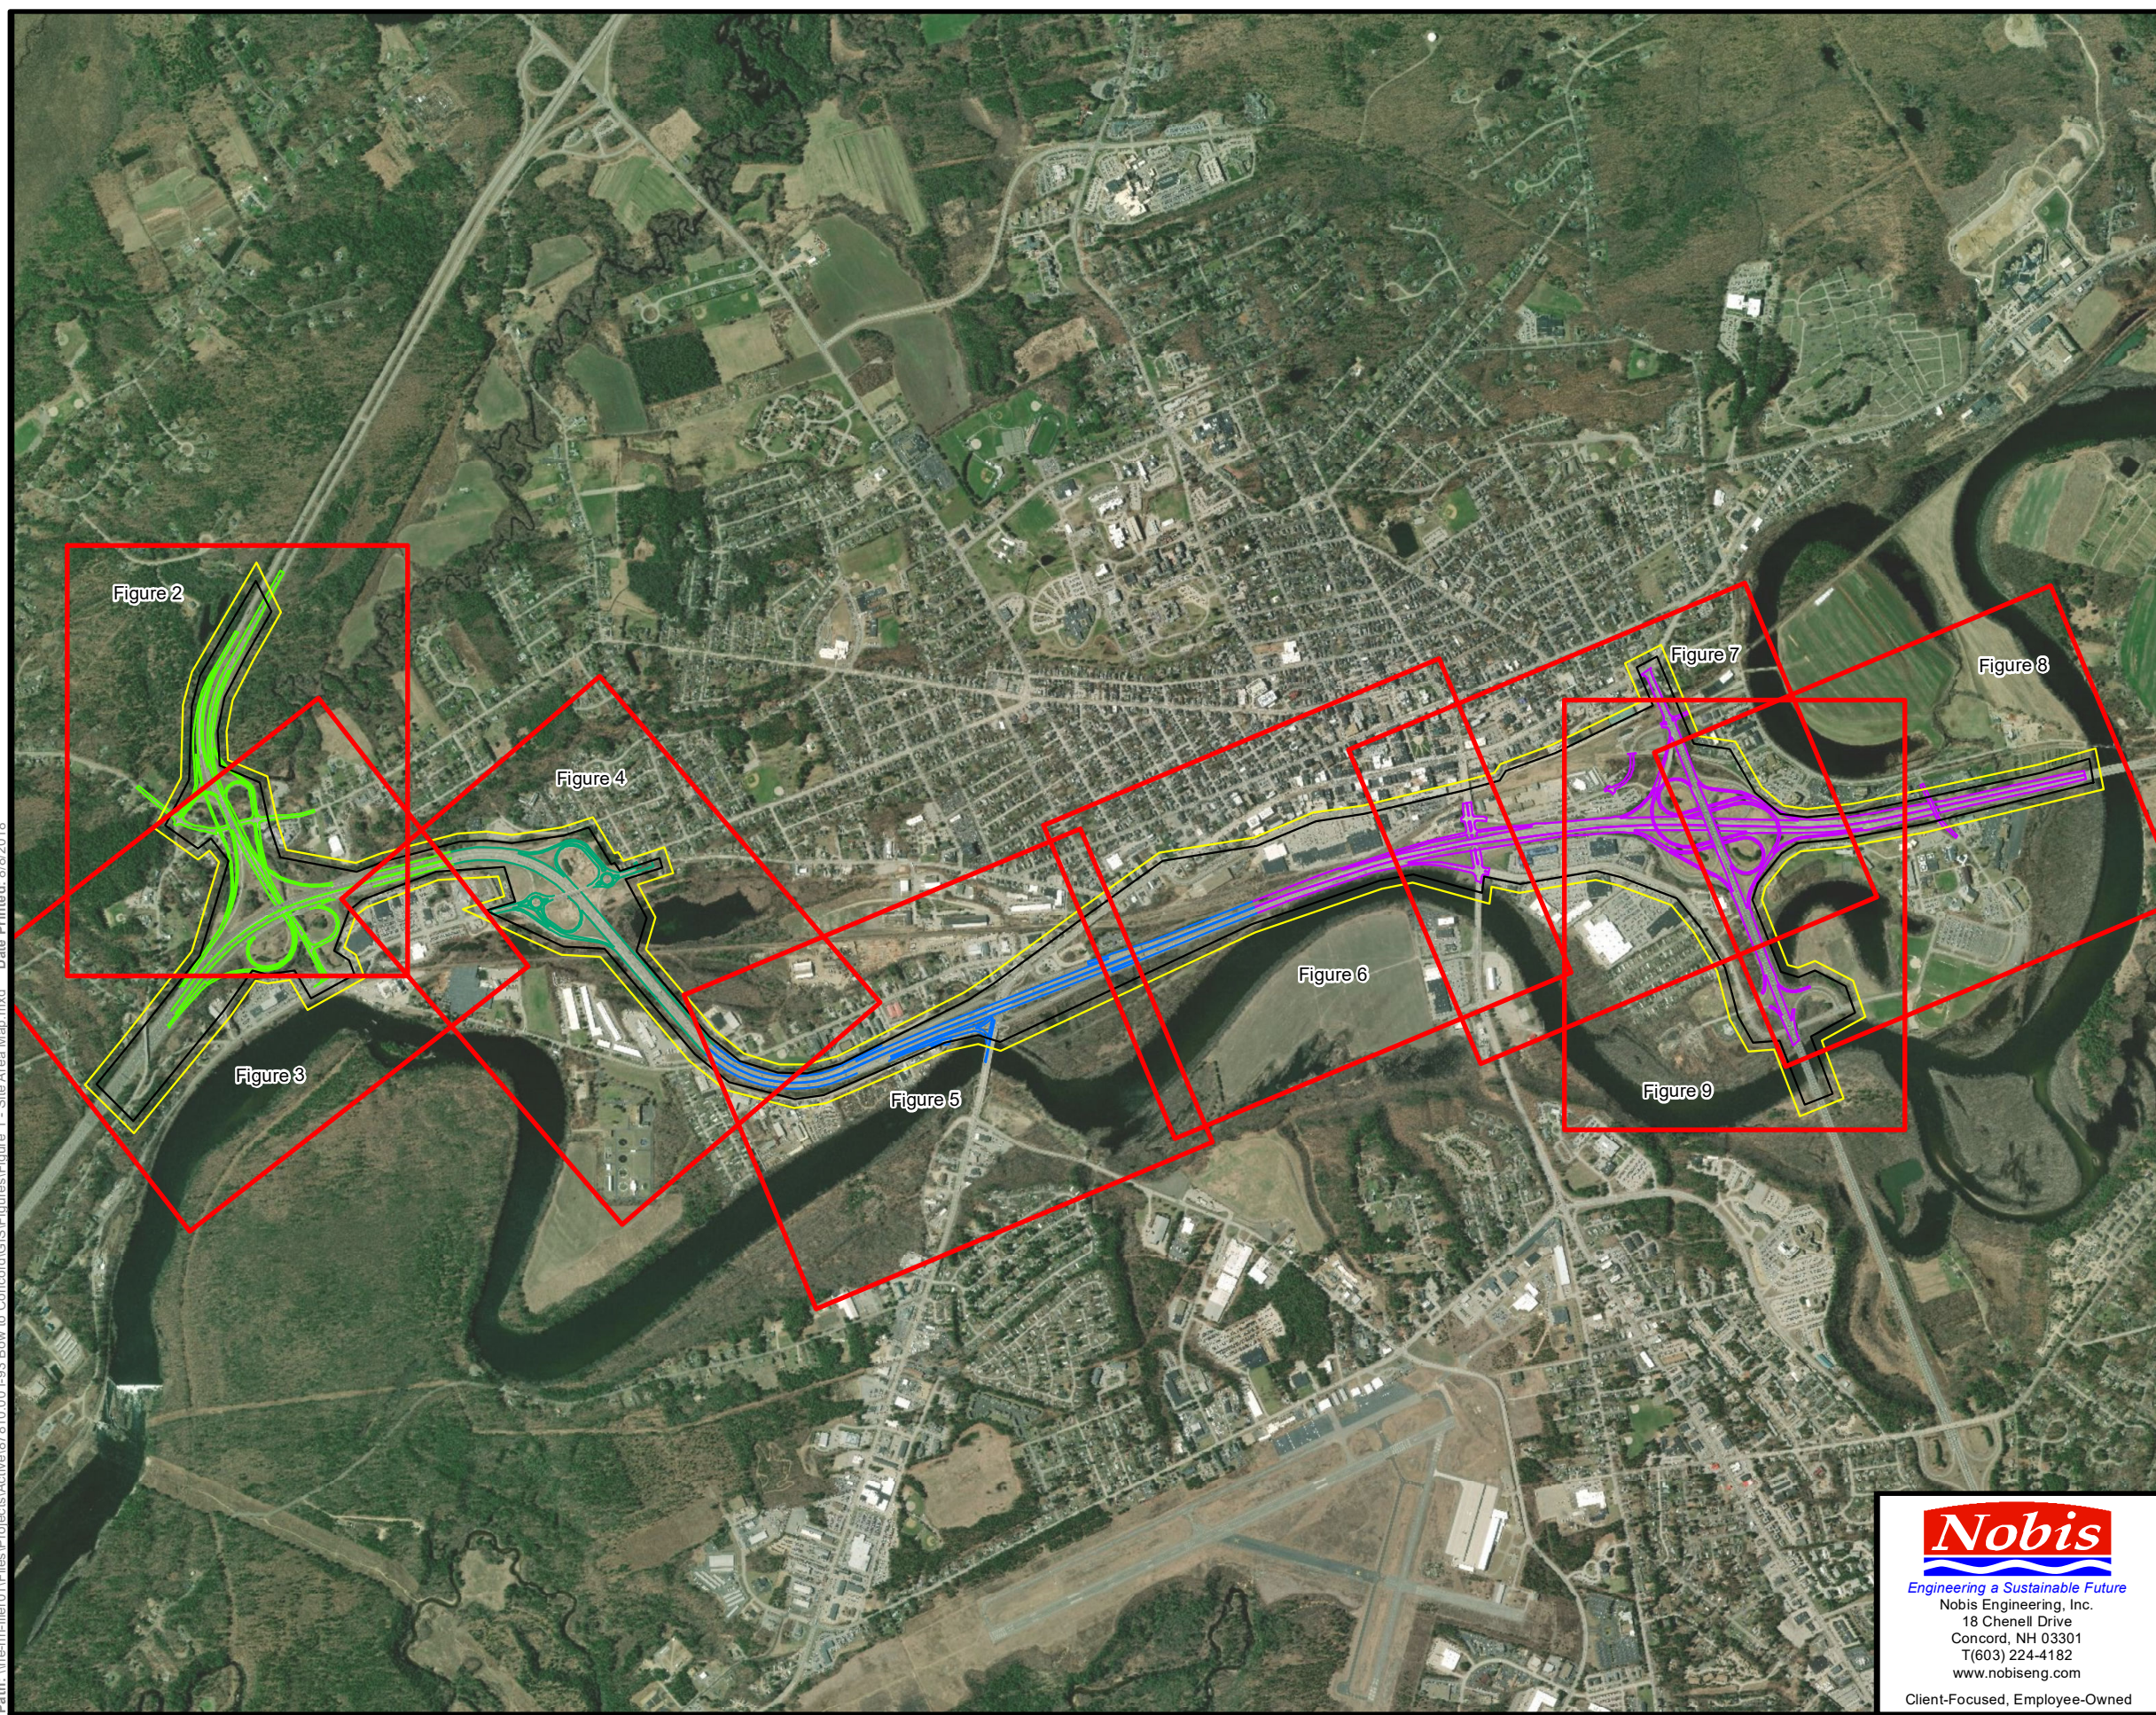
Path: \\ne-nh-filer01\Files\Projects\Active\87810.00 L-93 Bow to Concord\GIS\Figures\Figure 1 - Site Area Map.mxd Date Printed: 8/8/2018

The screening review of the corridor provides an initial listing of the contaminated sites within the corridor boundary and within a 100-foot setback from the corridor boundary, as depicted in Figure 1. If intrusive activities are to be performed, *e.g.*, excavations that might encounter known groundwater and/or soil contamination, additional assessment of the contaminated site may be required to manage potential exposure to petroleum or hazardous substances. A commercial database search, obtained from the commercial environmental due diligence database company EDR, Inc., was generated for the entire corridor boundary area, including the "Alternatives". Following the EDR report, the NHDES OneStop Geographic Information System (GIS) website was used to identify contaminated sites within the corridor boundary and 100-foot setback areas. The website includes NHDES project sites with administrative tracking records, such as underground storage tanks (USTs) and hazardous waste generators, as well as contaminated sites with documented discharges or suspected discharges of petroleum or hazardous materials. These contaminated sites are shown on the Asbestos Disposal Sites (ADSs) and Remediation Sites GIS layers. Due to the limitations of the OneStop GIS website for this application, a conservative approach was used where interpretation of the search distance was required, *i.e.*, some NHDES project sites reviewed may be just outside the corridor boundary and 100-foot setback area. Following the NHDES OneStop GIS website review, the New Hampshire Department of Transportation (NHDOT) Risk Assessment Survey for Contamination and Appraisal of Land (RASCAL) database was consulted for any additional known hazardous material concerns within the corridor boundary and 100-foot setback area.

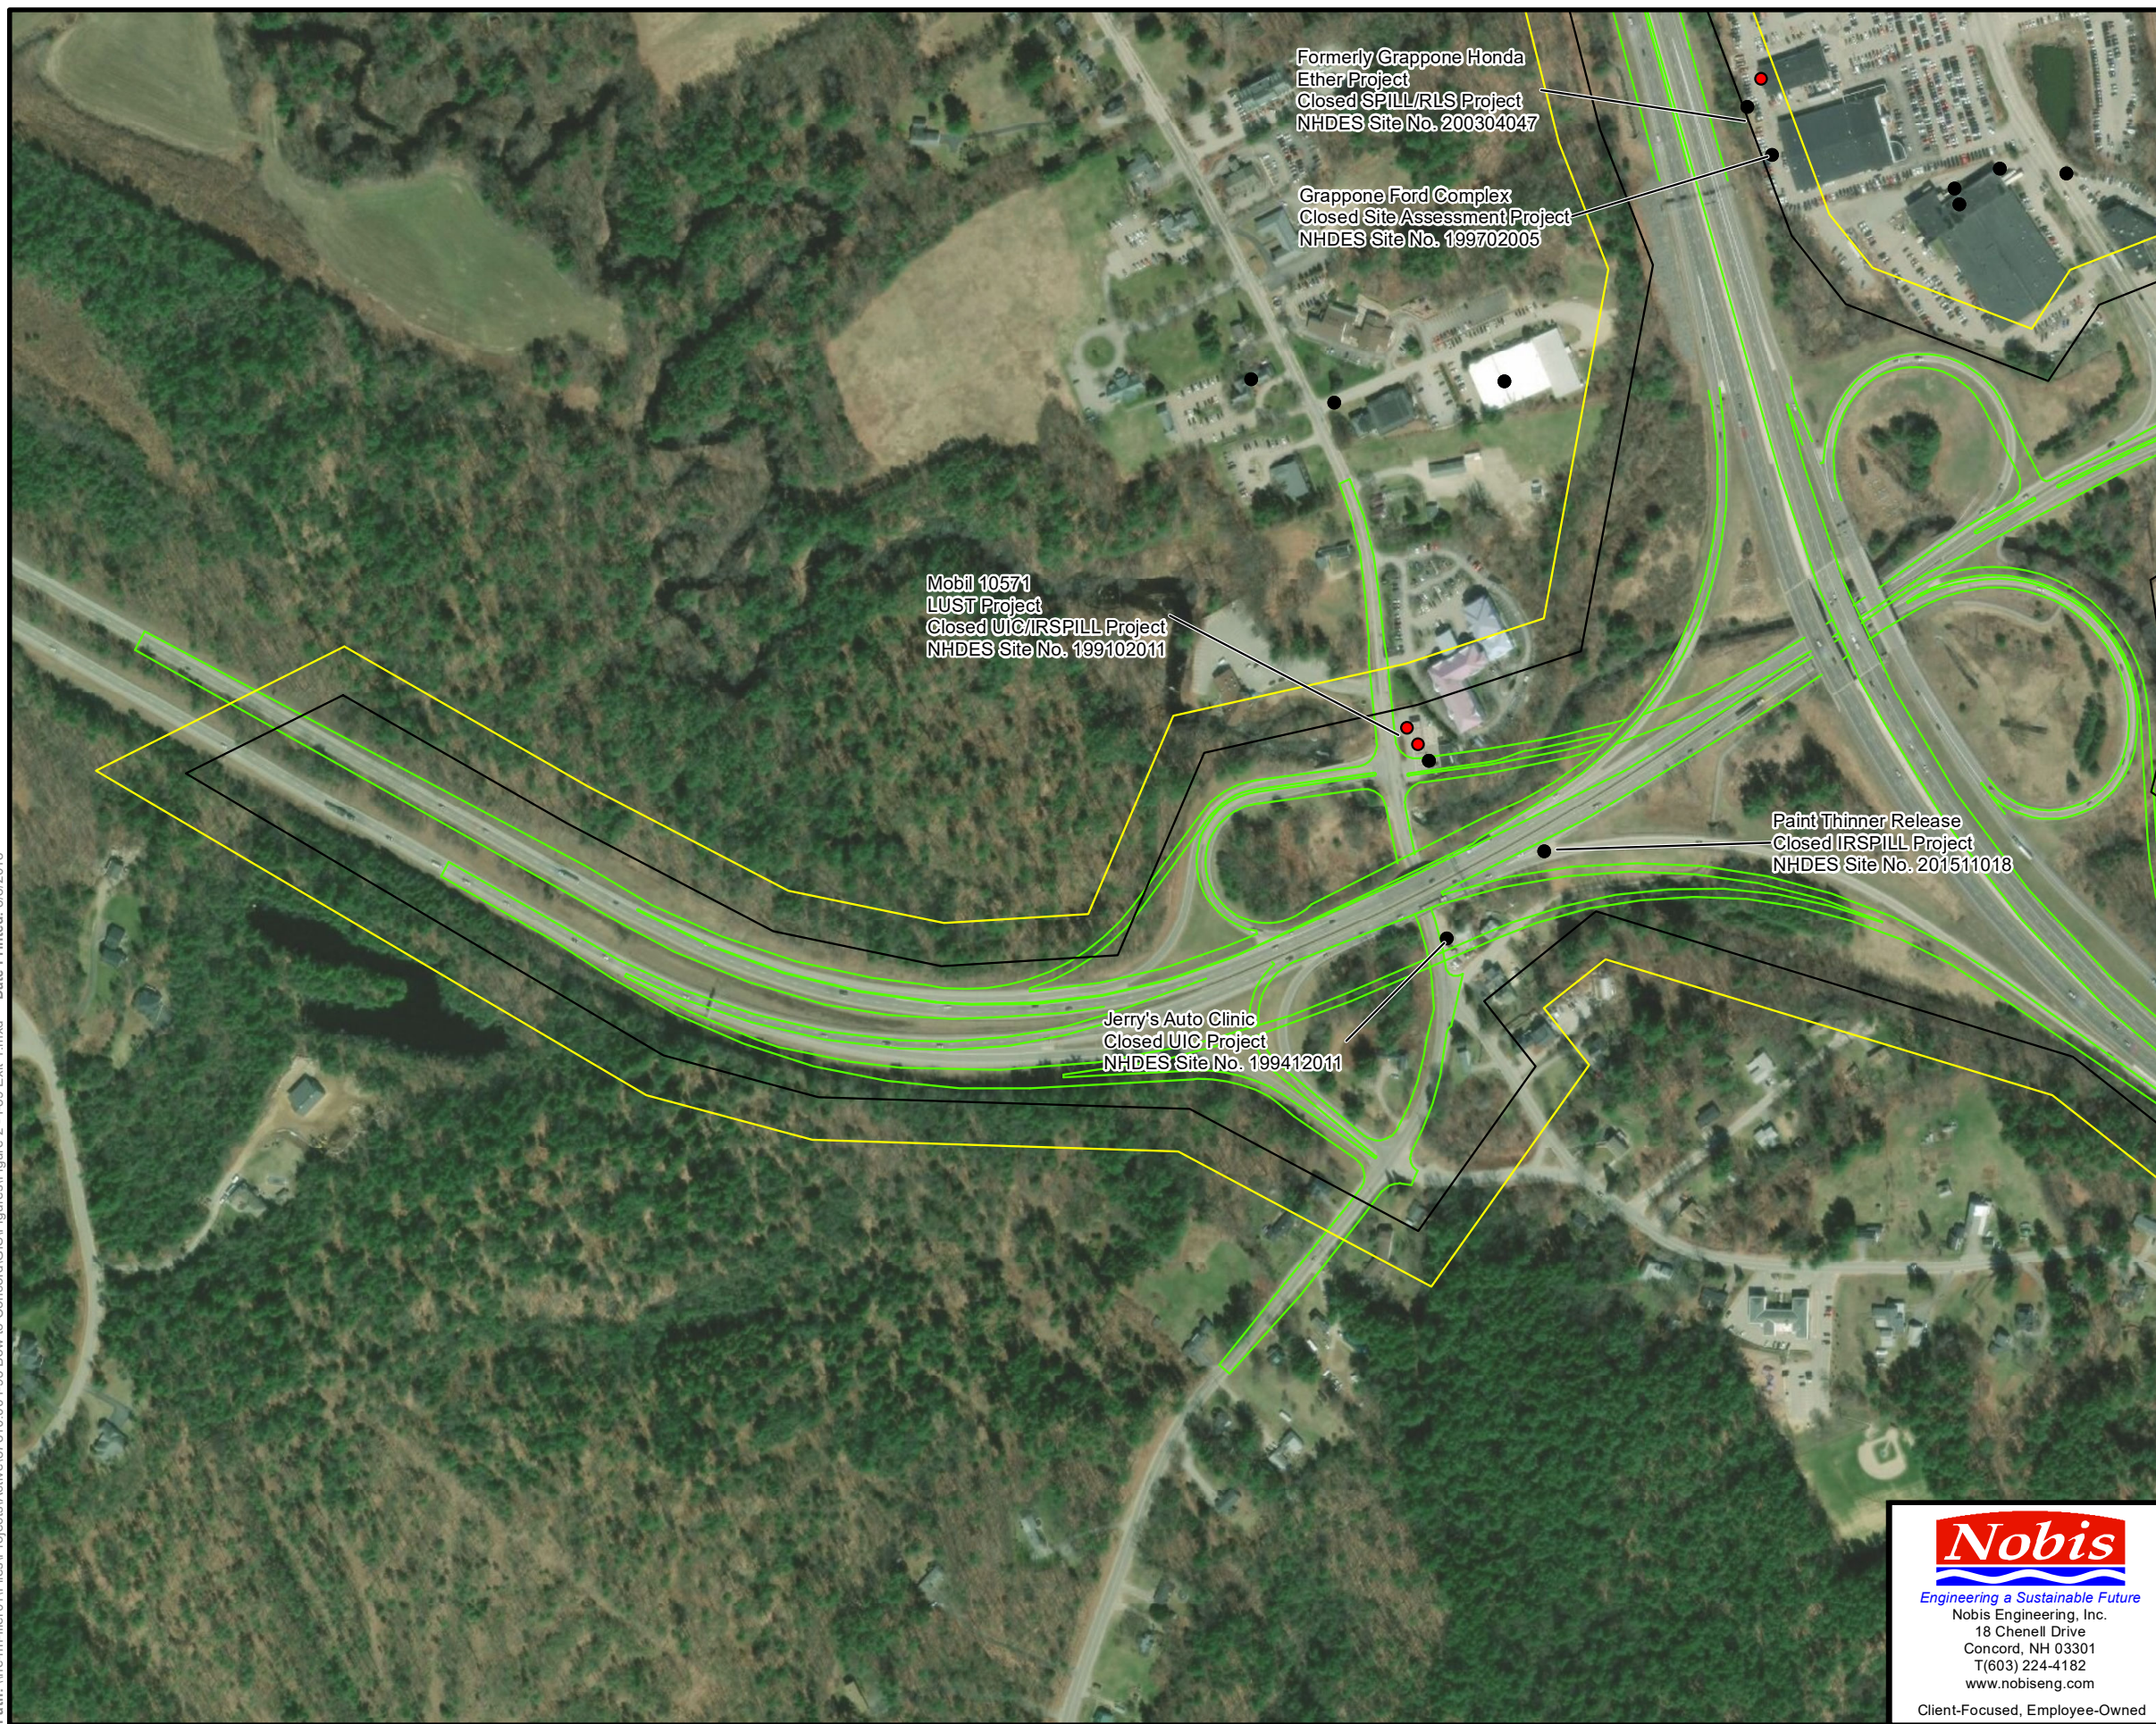
Path: \\ne-nh-filer01\Files\Projects\Active\87810.00 I-93 Bow to Concord\GIS\Figures\Figure 2 - I-89 Exit 1.mxd Date Printed: 8/8/2018

Three sites were identified within the I-89 Exit 1 section of the corridor (Table 2). Two of the sites are listed as closed in the NHDES database and include a paint thinner spill on the I-89SB ramp to I-93SB and an auto repair shop listed for underground injection control due to the presence of floor drains. The one open remediation site is a gas station for a UST petroleum release.

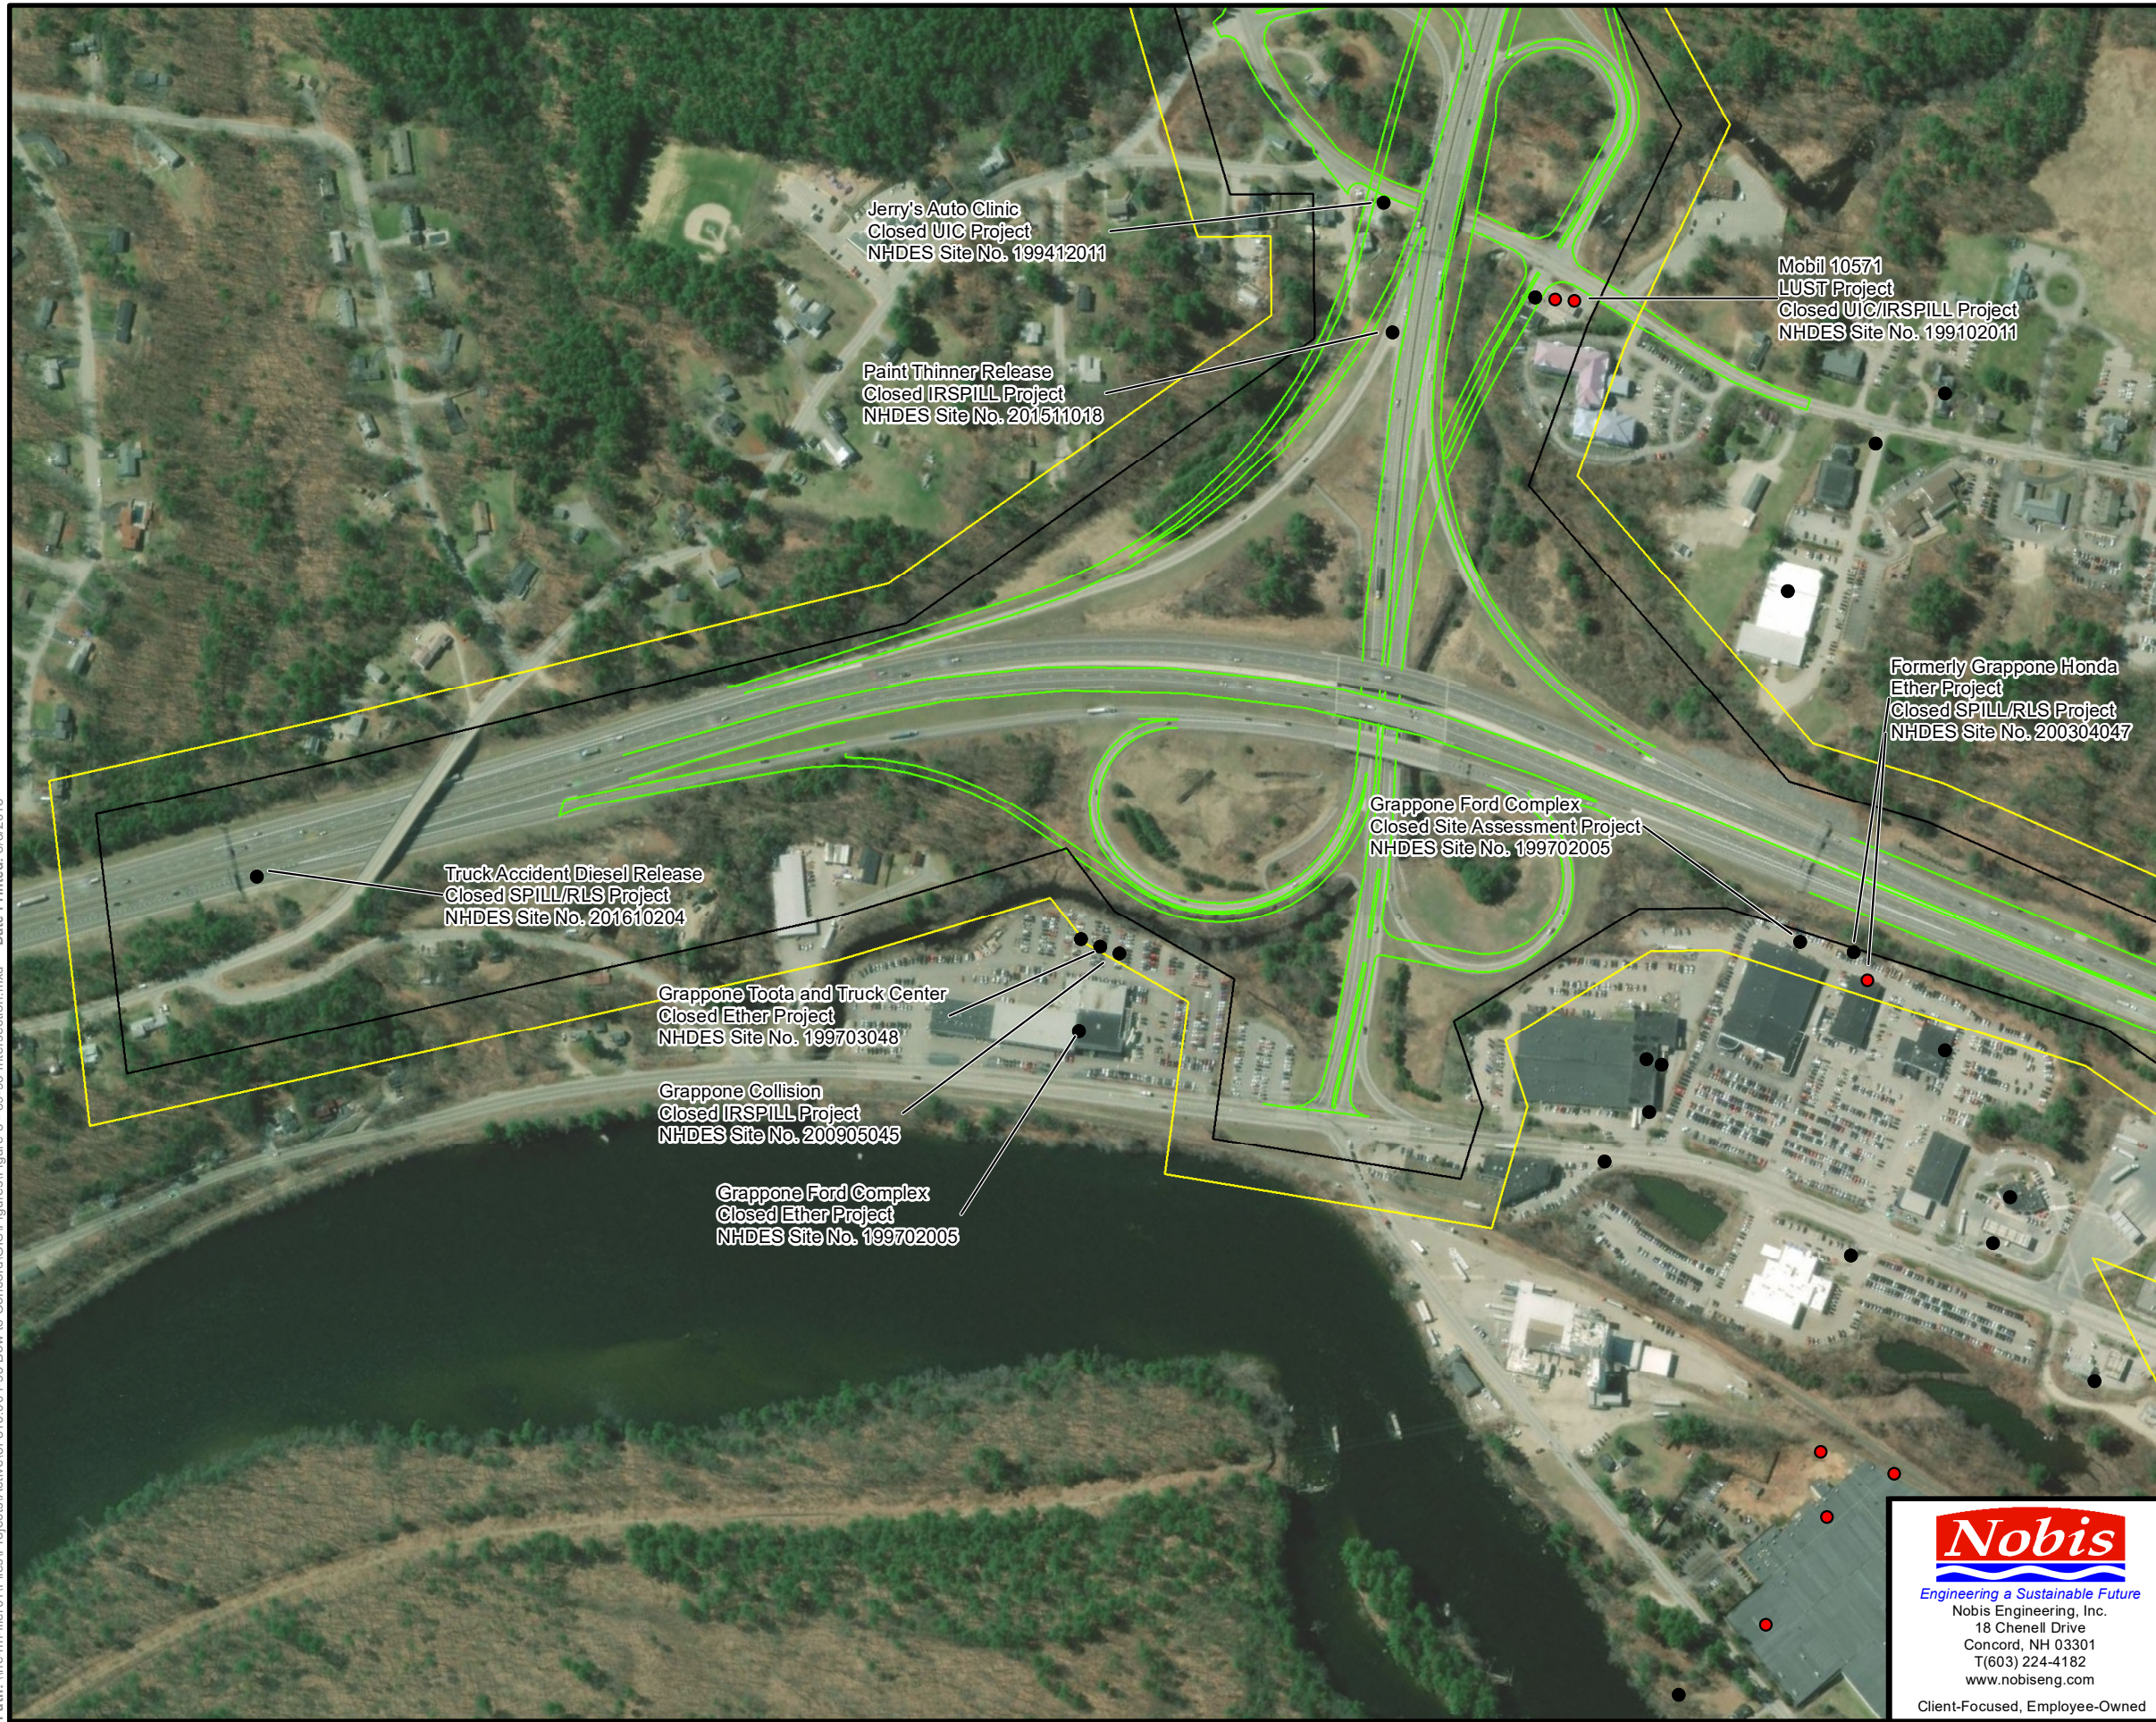
Path: \\ne-nh-filer01\Files\Projects\Active\87810.00 I-93 Bow to Concord\GIS\Figures\Figure 3 - 89-93 Intersection.mxd Date Printed: 8/8/2018

Five sites were identified within the I-89 and I-93 interchange section of the corridor (Table 3). Four of the sites are listed as closed in the NHDES database and include a diesel fuel release from a truck accident on I-93NB, a motor oil spill at Grappone Collision, and two ether releases at the Grappone facilities. The one open remediation site is the Former Grappone Honda for an ether release. The main contaminant of concern from an ether release is the gasoline additive methyl tert-butyl ether (MtBE).

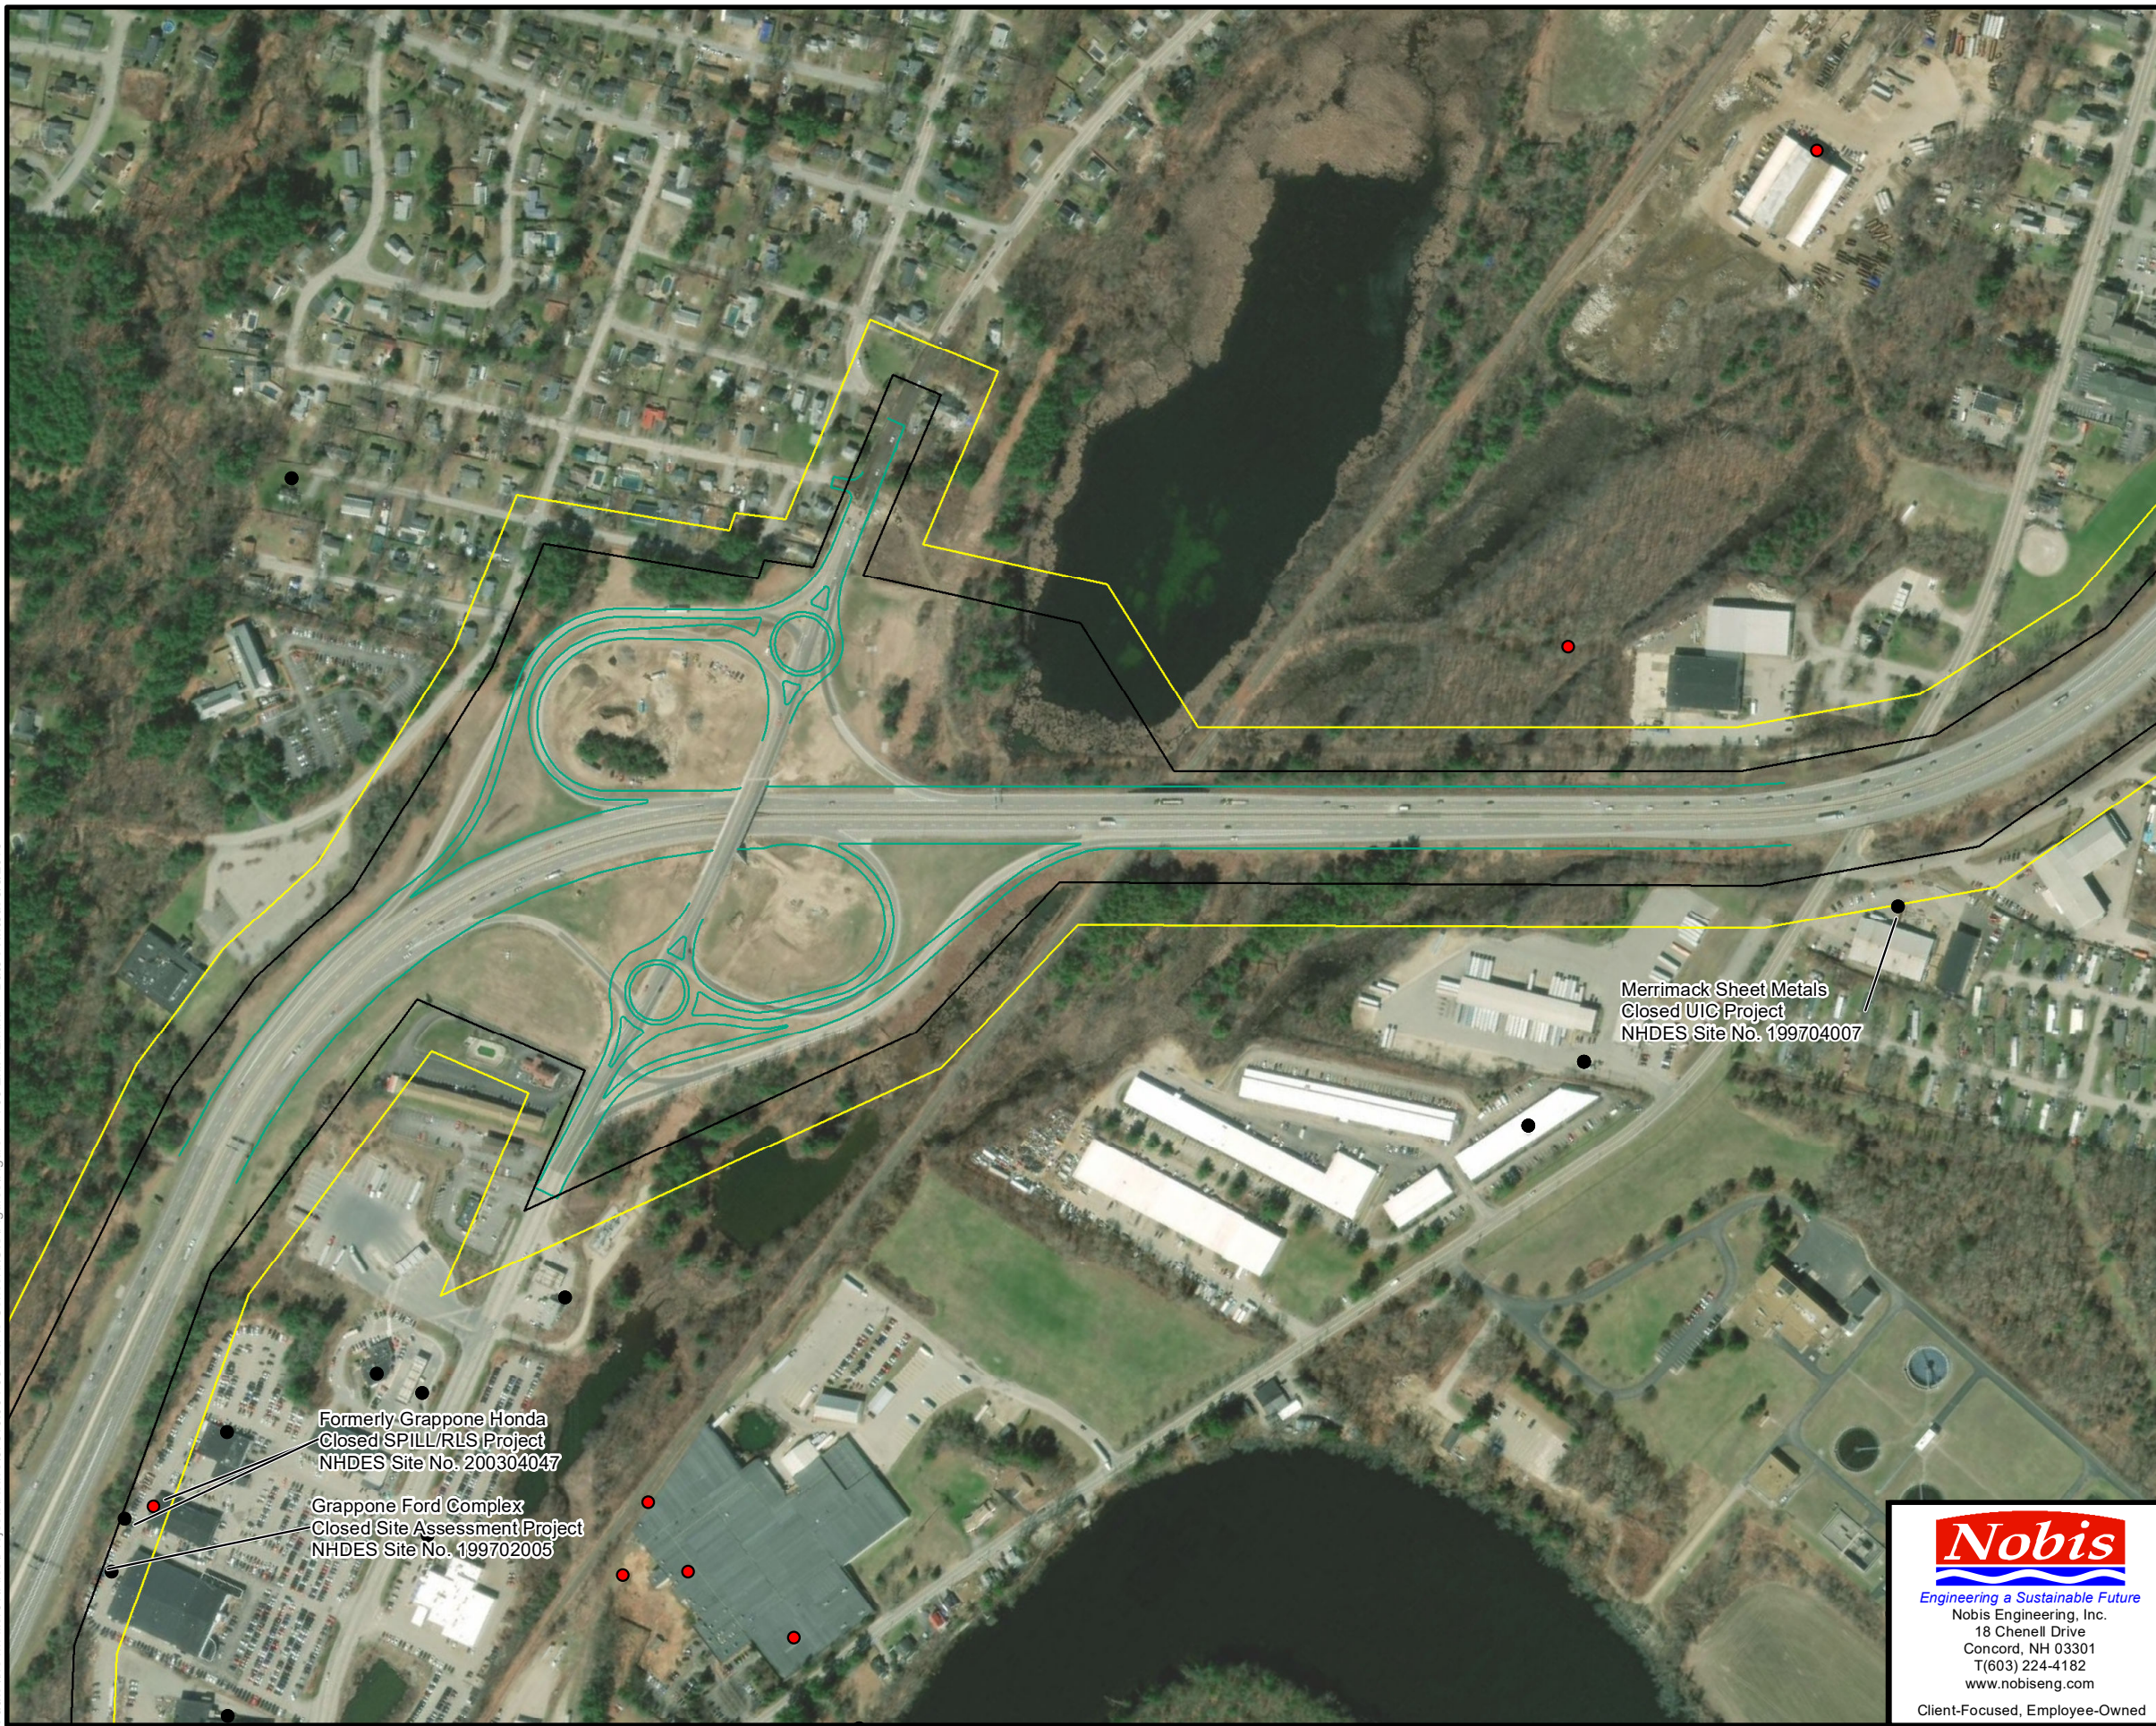
Path: \\ne-nh-filer01\Files\Projects\Active\87810.00 I-93 Bow to Concord\GIS\Figures\Figure 4 - I-93 Exit 12.mxd Date Printed: 8/8/2018

One site was identified within the I-93 Exit 12 section of the corridor (Table 4). The site, a sheet metal facility, where solvents were likely used, was listed for underground injection control due to the presence of floor drains. The site is listed as closed since 1997 in the NHDES OneStop database.

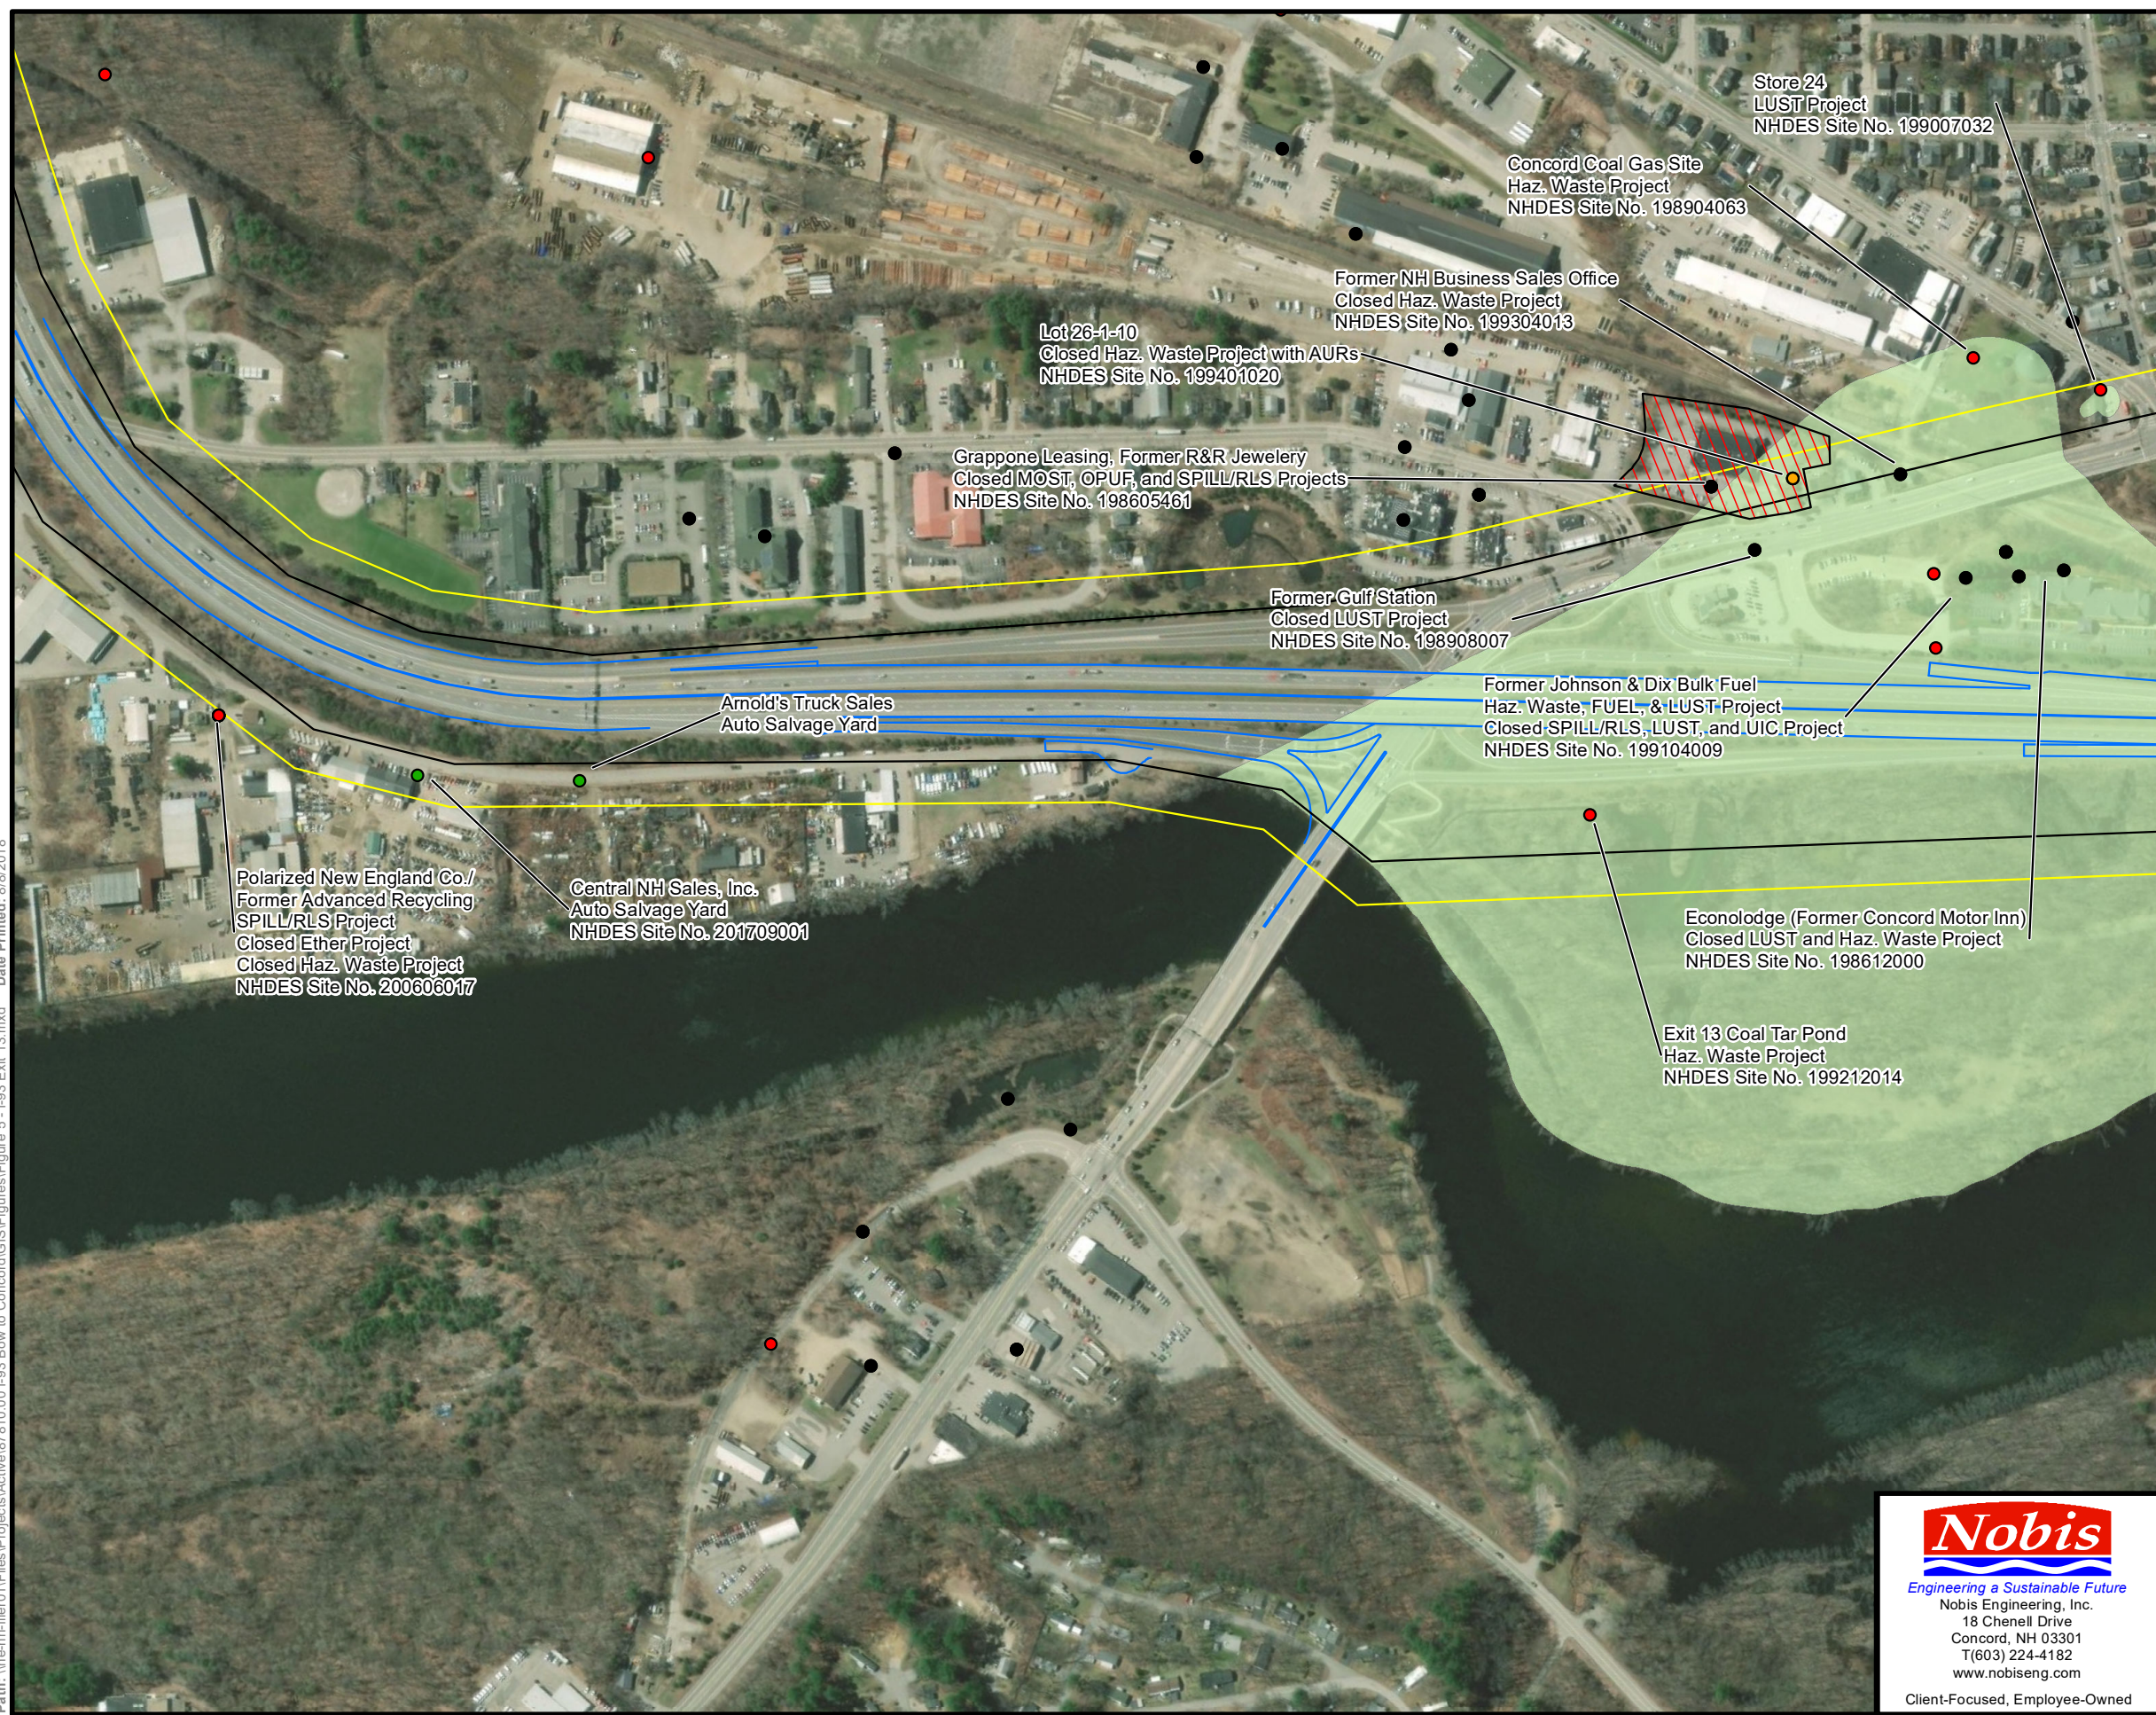
FIGURE 5

Ten sites were identified within the I-93 Exit 13 section of the corridor (Table 5). Five of the sites are listed as closed in the NHDES database and include releases from a former motel, a former gas station, a former commercial building, and a former jeweler. One of the closed sites was closed with an Activity and Use Restriction (AUR) in place. The five open remediation sites include the former Store 24 and the former Johnson & Dix bulk fuel storage facility for petroleum releases,

Former Advanced Recycling for PCE and TCE releases, and the Concord Coal Gas and Exit 13 coal tar pond for releases related to coal gas production. The Concord Coal Gas and Exit 13 coal tar pond releases have created a sizable plume of groundwater contamination. The approximate plume limits are depicted on Figure 5. Additionally, two auto salvage yards (not included in the site count) were identified within this section of the corridor. No documented releases from the salvage yards were encountered during review; however, due to the nature of salvage yards, a hazardous materials condition may be present at these locations.

Nobis understands that up to five non-intrusive Initial Site Assessments (ISAs) will be conducted on a limited number of properties in association with Part C of the Corridor Study. These properties along the corridor represent sites that are not already subject to NHDES oversight and reporting. Based on the data reviewed as part of this Hazardous Materials Evaluation, Nobis recommends that those ISAs be performed for the following sites:

- Central NH Sales, Inc., Auto Salvage Yard, Hall Street, Concord, NH
- Arnold's Truck Salvage, Auto Salvage Yard, Hall Street, Concord, NH

These properties were selected based on their past and/or current uses as automotive salvage yards, lack of prior investigations or analytical data available for review, and unknown current environmental conditions. These properties may be potential sources of contaminated media and/or hazardous materials and a hazardous materials condition may be present at these locations.
