HAZARDOUS MATERIALS EVALUATION REPORT

BOW TO CONCORD I-93 IMPROVEMENTS BOW / CONCORD, NEW HAMPSHIRE

NH State Project No. 13742

**Nobis Project No. 87810.00
AUGUST 8, 2018**

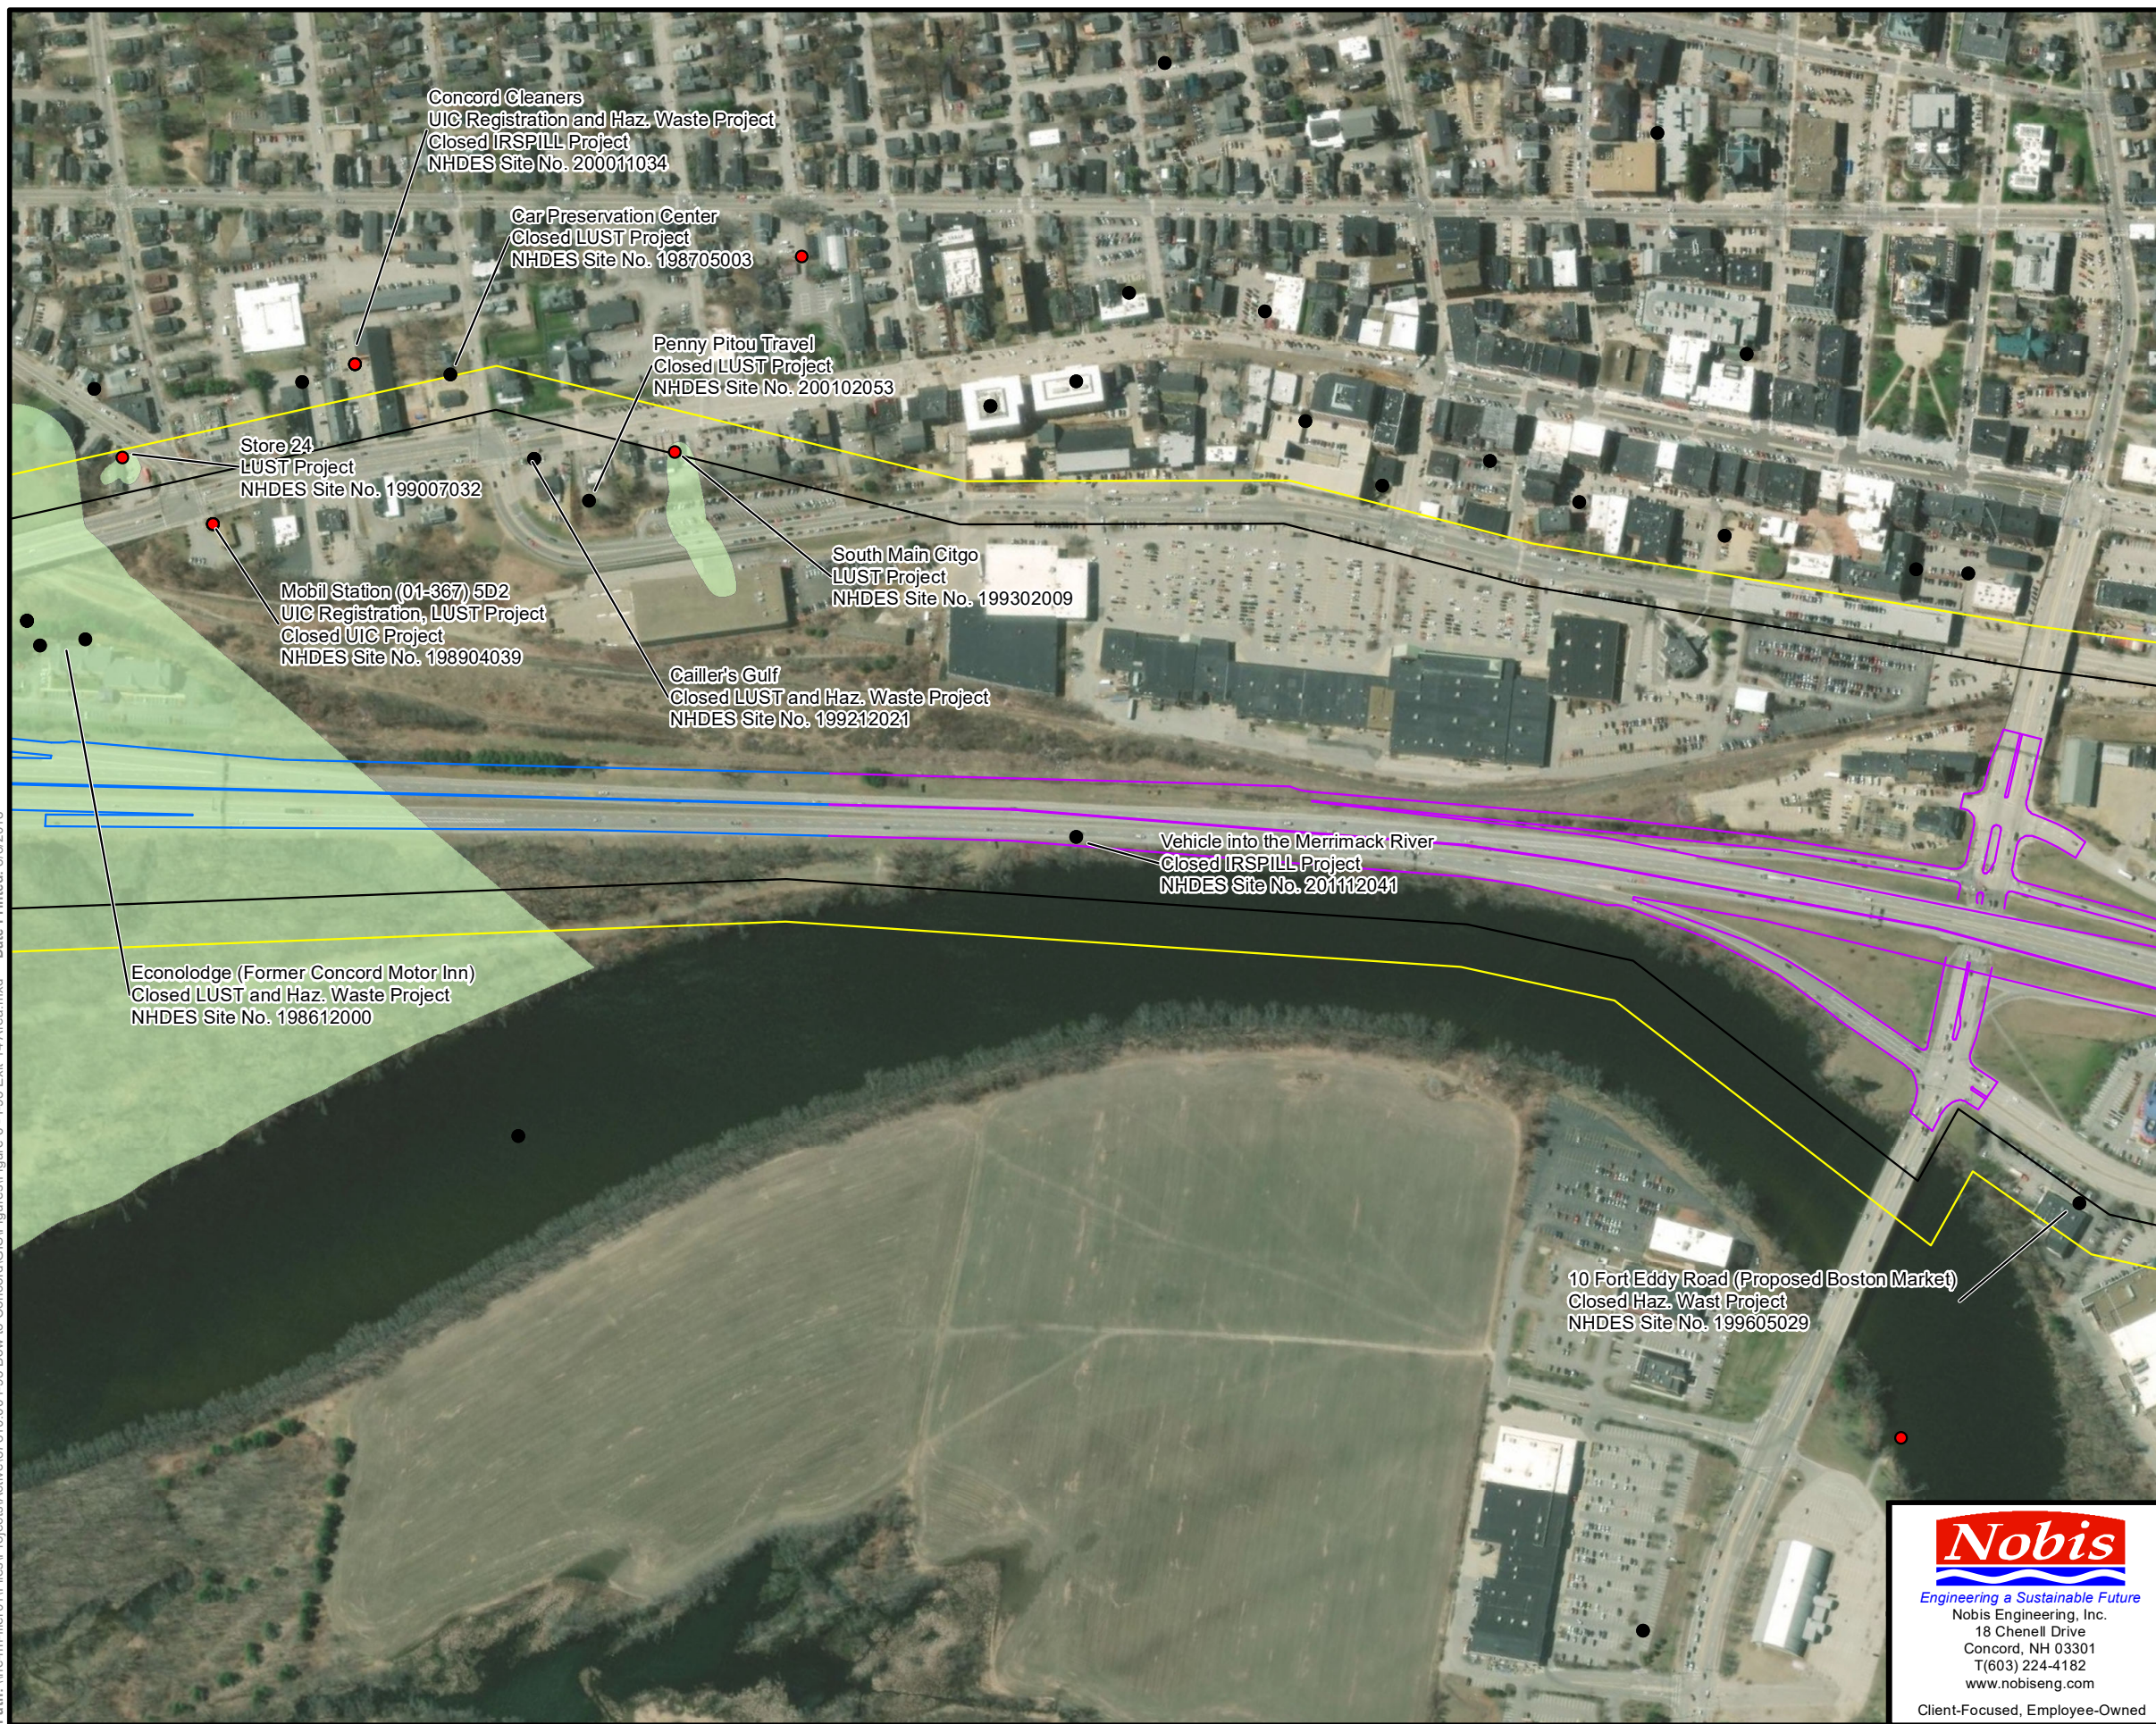
FIGURE 6	
I-93 EXIT 14 AREA CONCEPT D2 I-93 CORRIDOR BOW/CONCORD, NEW HAMPSHIRE	
PREPARED BY: NZ	CHECKED BY: JR
PROJECT NO. 87810.00	DATE: JANUARY 2018

Eight sites were identified within the I-93 Exit 14 Area section of the corridor (Table 6). Five of the sites are listed as closed in the NHDES database, including a motor oil release from a car accident on I-93NB at mile marker 37.9 and releases from a former gas station, a car service center, and former commercial buildings. The three open remediation sites include two gas stations with UST petroleum releases and former Concord Cleaners dry cleaner PCE release. One of the former gas station sites has an associated plume of groundwater contamination. The approximate plume limits are depicted on Figure 6.

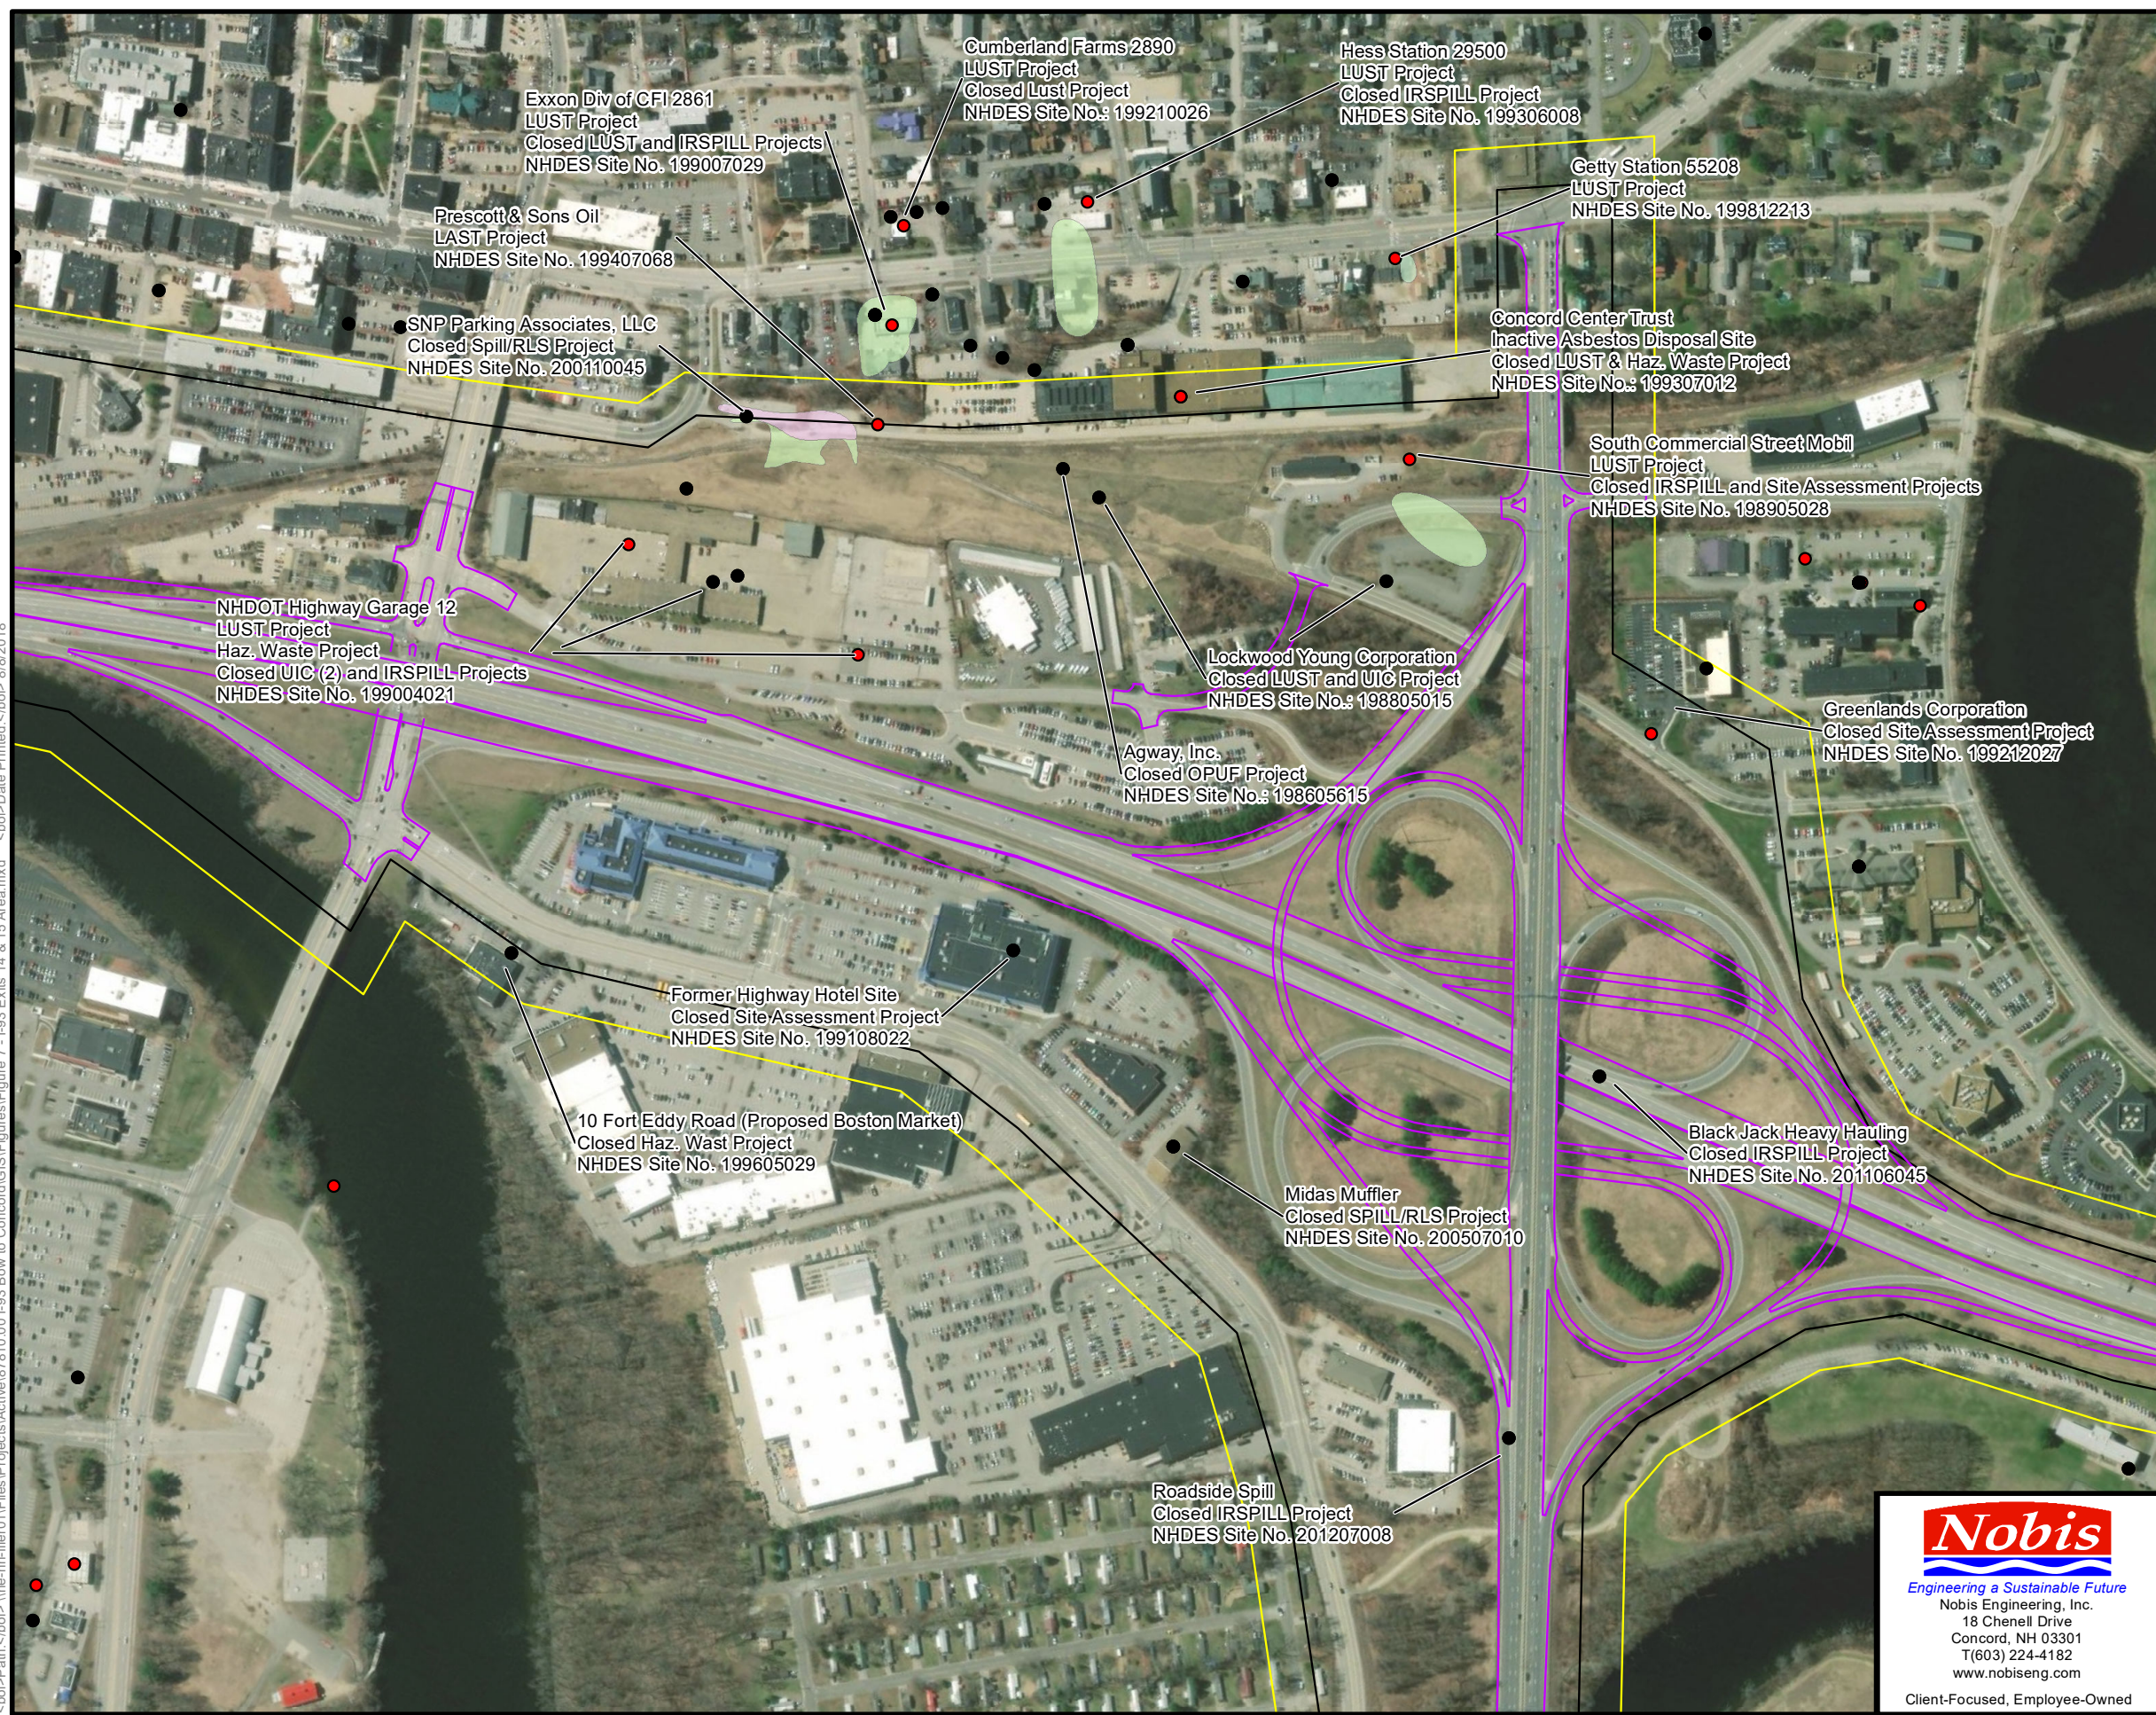
FIGURE 7	
I-93 EXITS 14 AND 15 AREA CONCEPT D2 I-93 CORRIDOR BOW/CONCORD, NEW HAMPSHIRE	
PREPARED BY: NZ	CHECKED BY: JR
PROJECT NO. 87810.00	DATE: JANUARY 2018

Sixteen sites were identified within the I-93 Exits 14 and 15 Area section of the corridor shown on Figures 7 through 9 (Table 7). Eight of the sites are listed as closed in the NHDES database and include a diesel fuel release from a truck accident on I-93SB at Exit 15 and another at the I-93/I-393 interchange, a gasoline spill on Storrs Street, releases from commercial buildings, and a former hotel. The eight open remediation sites include five gas stations with UST petroleum releases, a NHDOT facility with a UST release, an above ground storage tank release of fuel oil, and an inactive asbestos disposal site (ADS). Several of the open sites have associated plumes of groundwater contamination. The approximate plume limits are depicted on Figure 7.
